## UNIVERSITY ROOF RESTORATION

Case Study

**Project Type:**  
Roof Overlay

**System Installed:**  
IR-26 Polymer Resin

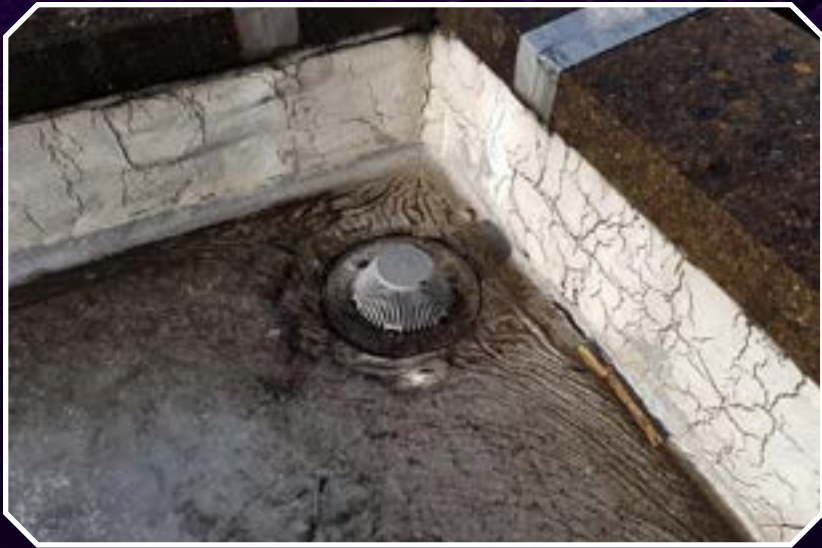
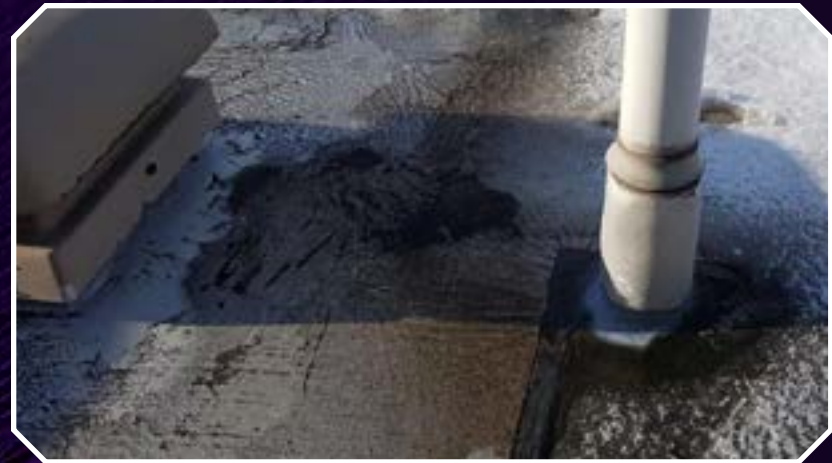
The existing roof included multiple areas of aged bituminous surfacing that required localized repair and preparation before a new waterproofing system could be installed. Surface defects, cracks, and irregular areas had to be corrected to establish a sound, consistent substrate for the overlay.

Roof perimeters and junctions also included numerous parapet conditions that represented potential points of water entry.

These vertical transitions and exposed perimeter details needed to be incorporated into a continuous waterproofing assembly without creating unnecessary seams or complicated termination points.

The existing roof surfaces were repaired where required, including filling and leveling localized defects, followed by thorough cleaning and preparation to create a suitable substrate. Parapet faces and tops were prepared as needed so the waterproofing membrane could transition continuously from the horizontal roof surface onto vertical and perimeter conditions.

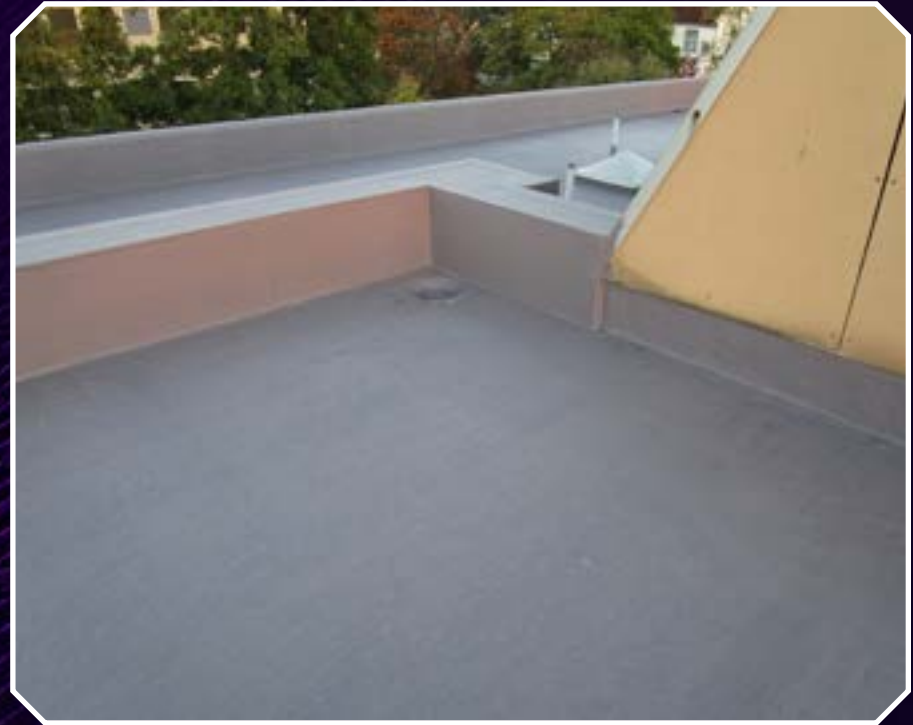
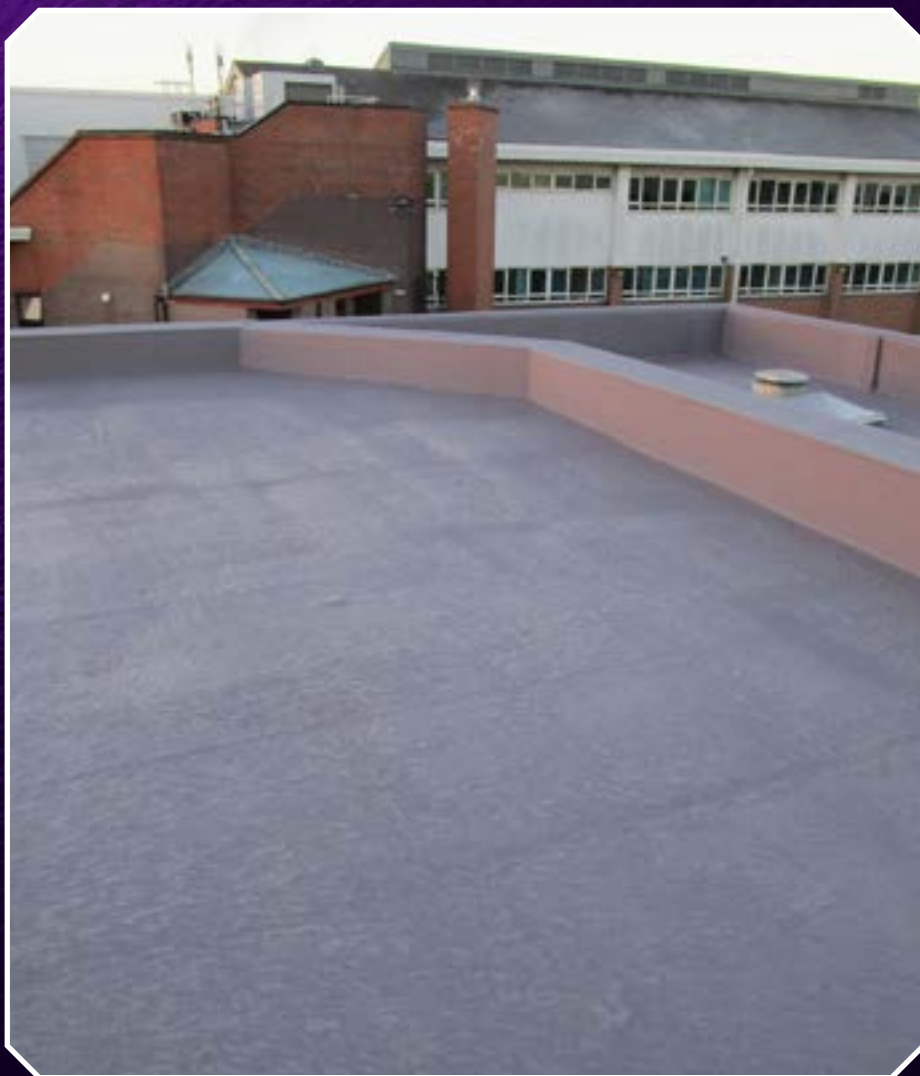
After required priming, IR-26 was installed with continuous polyester reinforcement to form a fully bonded, seamless waterproofing layer across the roof. The liquid-applied membrane conformed closely to changes in plane, parapets, perimeter details, and other roof geometry, reducing reliance on the laps, seams, and welds associated with many conventional sheet systems.

The rapid-curing characteristics of IR-26 supported efficient installation and re-coating, allowing completed sections to progress quickly toward full waterproofing. Designated rooftop walkways were also incorporated where required using an aggregate-finished surface to provide a defined route for routine rooftop access.
