**IMPERMITEK**  
Advanced Seamless Technologies

## SCHOOL GUTTER REFURBISHMENT

Case Study

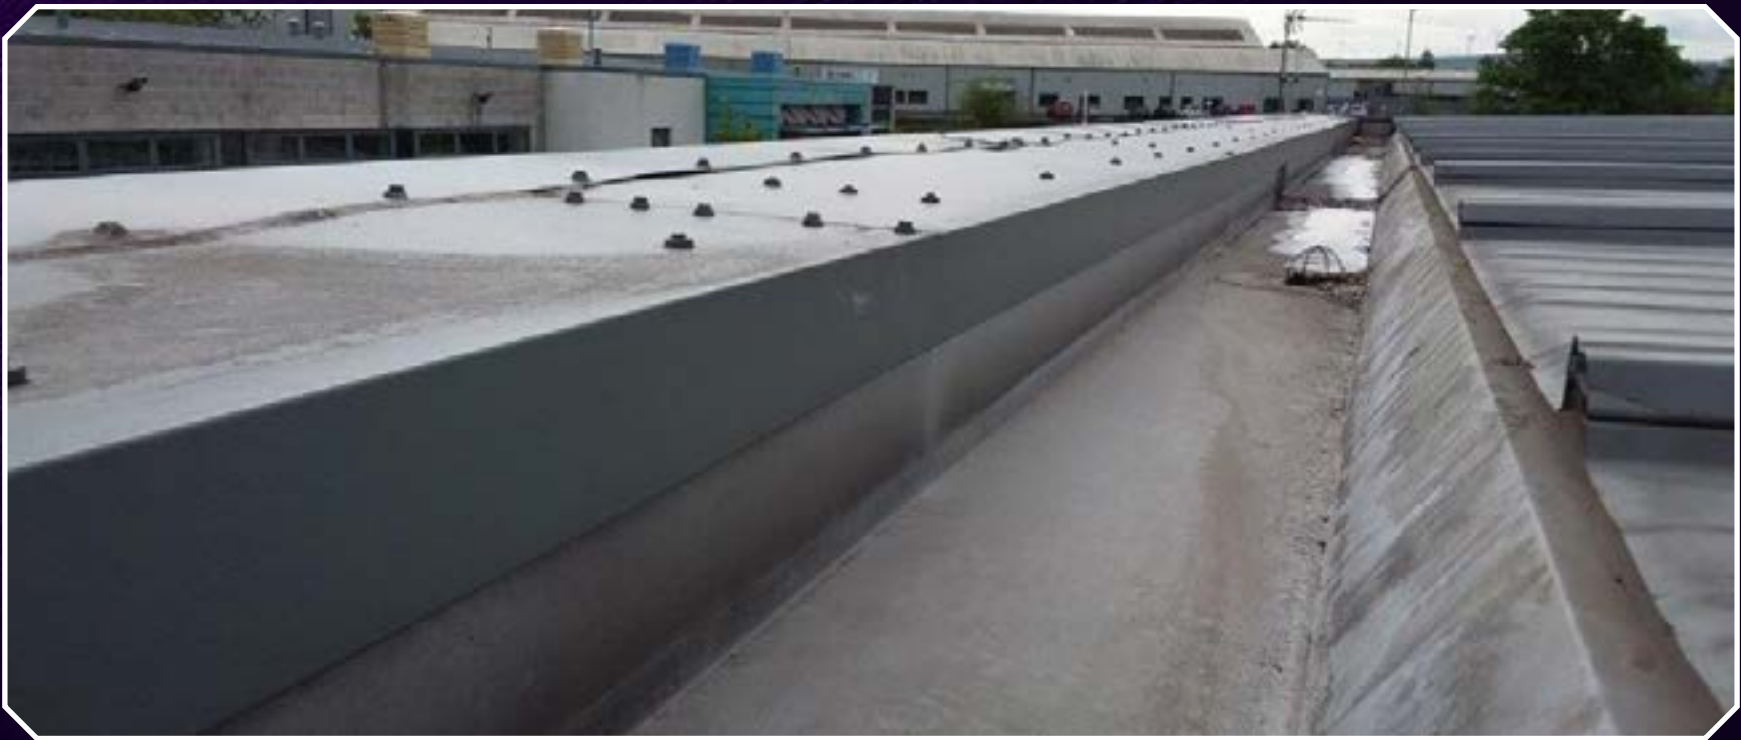
A site assessment identified an aged single-ply waterproofing membrane with multiple reported leaks and previous localized repairs that had not provided a lasting solution. The existing build-up incorporated a galvanized steel deck with a coated finish. The gutters and parapet cappings remained serviceable as a substrate, but required a high-performance waterproofing overlay to restore long-term weather protection and reduce the risk of further water ingress.

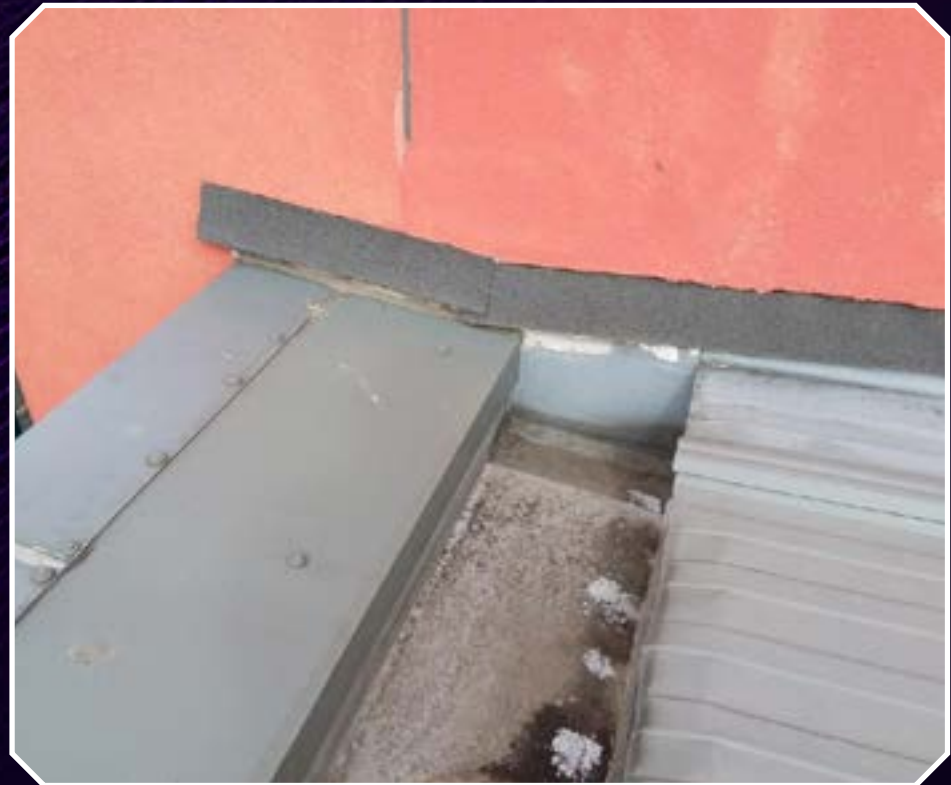
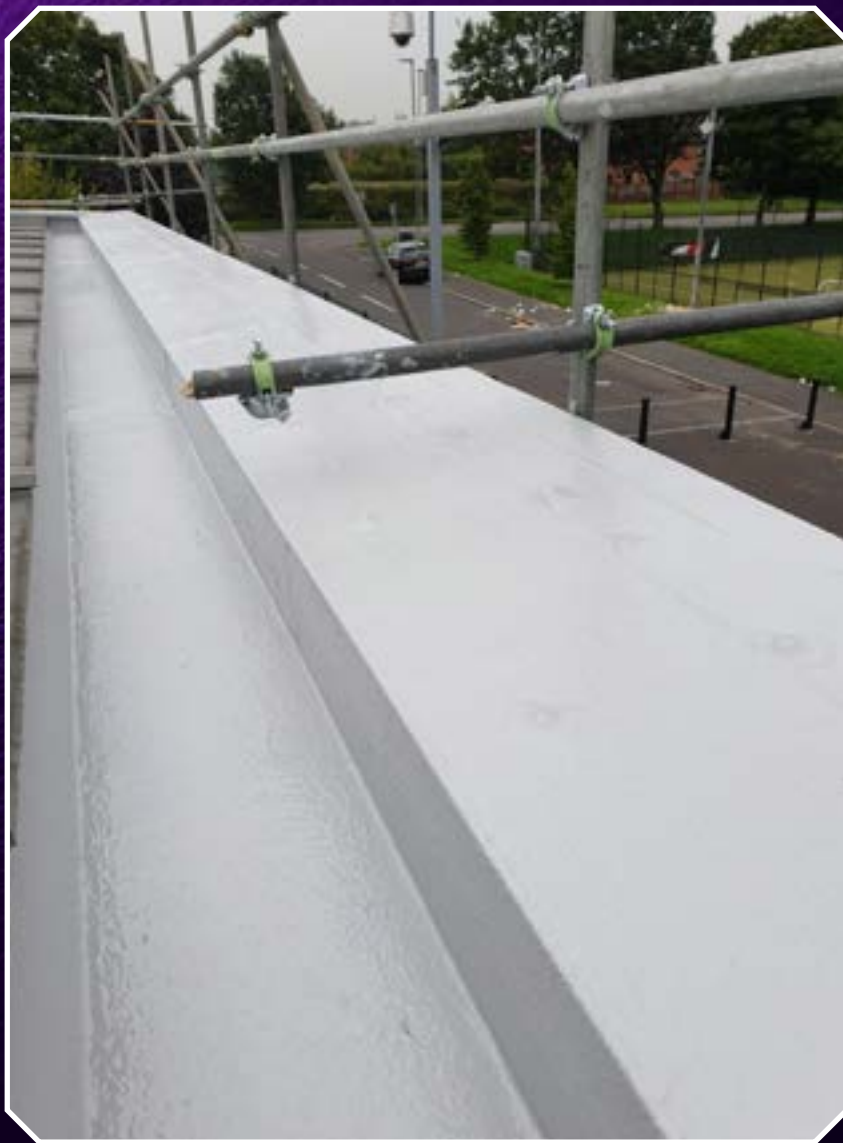
The existing waterproofing was retained and made good where required to create a sound, smooth substrate. All installation areas were thoroughly cleaned to remove dirt and debris before application. Relevant surfaces, including the existing single-ply membrane, were prepared with an appropriate Impermitek primer. Joints, bolt heads and other vulnerable details were reinforced using Impermitek detailing materials, while pre-formed Impermitek edge trims and new flashings were installed where required to protect exposed insulation and perimeter details.

The IR-26 waterproofing system was applied in accordance with the Impermitek project specification. The first reinforced coat was installed over the prepared substrate and allowed to cure before application of the final coat. The system's rapid-cure properties supported an efficient installation sequence while delivering a seamless, durable waterproofing finish across the refurbished areas.
